Quality Assurance and Source Inspection

WELDING INSPECTION REPORT

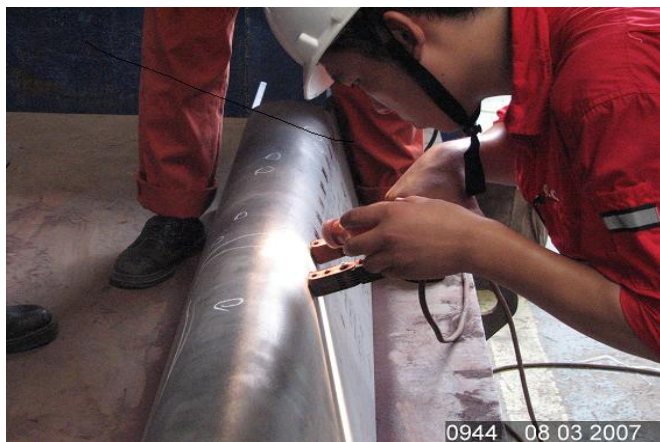
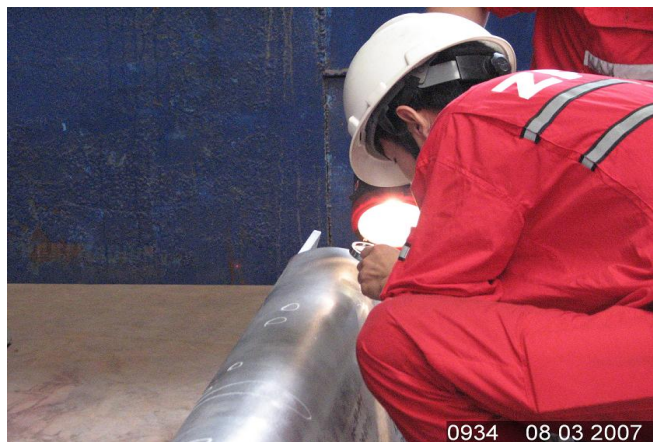
The CALTRANS Quality Assurance (QA) Inspector, Alfredo Acuna was present for the ZPMC visual inspection (with a 5x magnified glass) and magnetic particle testing (MT) after the cold bent steel plate trial for the orthotropic deck, close ribs # 7, 8 and 9 designated as V101, V103 and V105 respectively. The testing was at the OBG ZPMC fabrication facility in Shanghai, China for the San Francisco Oakland Bay Self Anchored Suspension Bridge. The QA Inspector observed that the testing was performed by approved ZPMC QC MT ASNT level II, Cai Xinxin. Mr. Cai was following the AWS D1.5, Section 6 requirements. ABF representatives Kevin Carpenter, Peter Ferguson, Warren Buehler, ZPMC representative, Xu Jun and Shen Xue Jun, and Caltrans Task Leader Robert Cuellar were present during the trial. The QA inspector observed that the MT and visual examinations appeared to be in compliance with contract documents. The QA inspector selected randomly 5 areas for Caltrans destructive testing (macroetch testing on the cutting edges) on the above mentioned close ribs as required per the special Provisions.

The photos below show ZPMC performing MT and visual examinations with the 5x magnification glass on the bending close rib trial.
